SunetC 200G

Magnus Bergroth posted on May 25, 2020

We made a design where we put one mx10003 and two CloudConnect with one quadflex card in each city. The Quadflex card has two line connections that can run in 100G or 200G mode and four 100GE QSFP28 ports. The Adva box can run in a backwards compatibility mode so it can talk to the Juniper Cordoba card. It's the same chipset manufacturer in both the Adva box and the Juniper card.

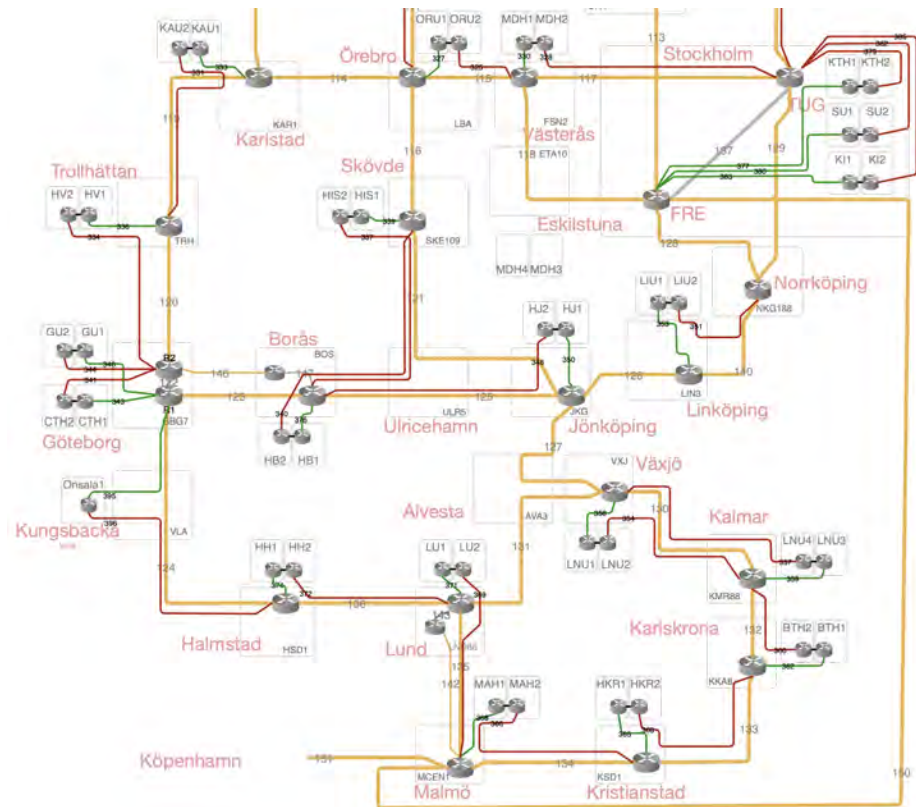
The SunetC design connects the universities in each city with one gray LR4 100GE connection between the university and the City pop and one DWDM link that goes to the next city.

If you look closely on the network diagram you will see that there are 5 waves going into Lund. But we have only four DWDM ports in the Adva boxes. To solve this we are moving Halmstad universites DWDM connection in the other direction and it will got to Göteborg instead of Lund. The Göteborg router is an Juniper MX2010 and it needs an adapter card to run the DWDM card. That card will be taken from the Malmö router, but is currently borrowed from a router that is waiting to be installed in Stockholm.

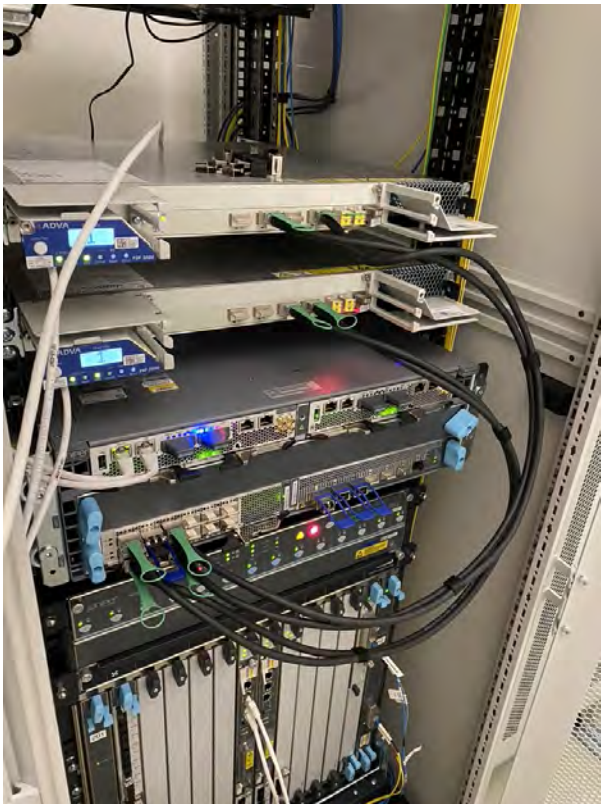
There were plenty of space in the rack in Linköping:

The small issue is that the Juniper MX960 and the MX10003 has different distance between the front and the back rack post. And the installed equipment made it impossible to move the posts.

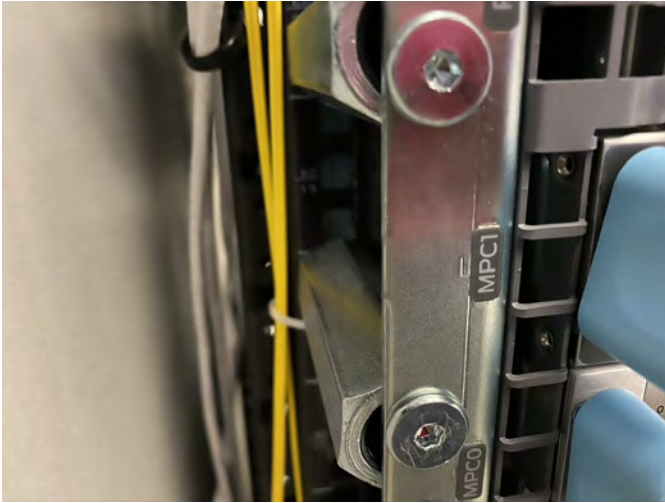
A trip to the local company Biltema were some M16 long nuts and long m6 bolts over bridged the 75mm gap.

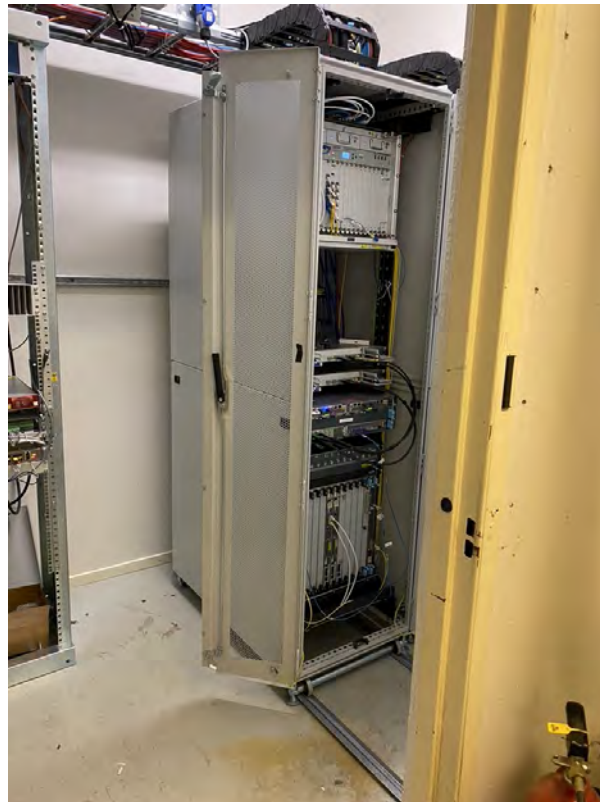
The racks are on rails so that you can go in behind them and as the PDU:s are on the back of the rack it's the place I spent the most of the time. Fibers and power are going in chain-tracks on top off the racks.

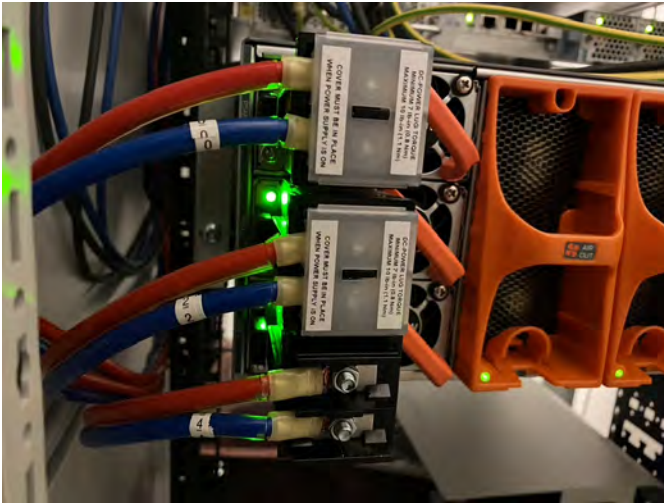
The power needed to be completed, both routers are powered on at the same time to minimize the downtime during the migration. The new mx10003 are running on B-power and the old MX960 on A-power. The power cable were on backorder when the router was first installed so only two of six feeds were cabled.

This is the A-side of the MX10003. Those safety plastic covers are a joke, they snap on but they do not sit very tight so if get close with a hammer or any other tool they get lost.

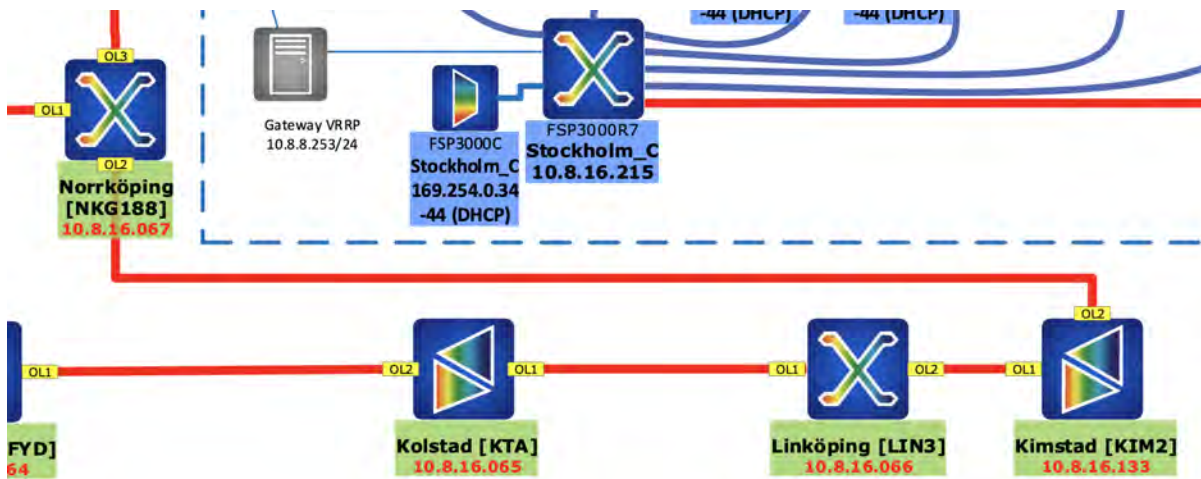
The Distance between Norrköping and Linköping is only 50km, but the city fiber was so bad so we couldn't run Raman amplifiers, so we added an amp site in between.

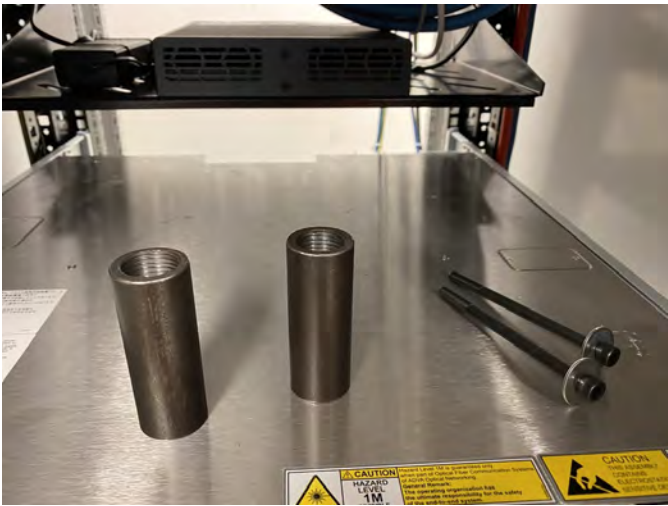
The rack had the same problem as the rack in Linköping, the posts were to close together. The "shims" were upgraded to m15 black iron pipe nuts.

But I forgot to clean them, they are rust prevented with oil, so it got a bit messy.

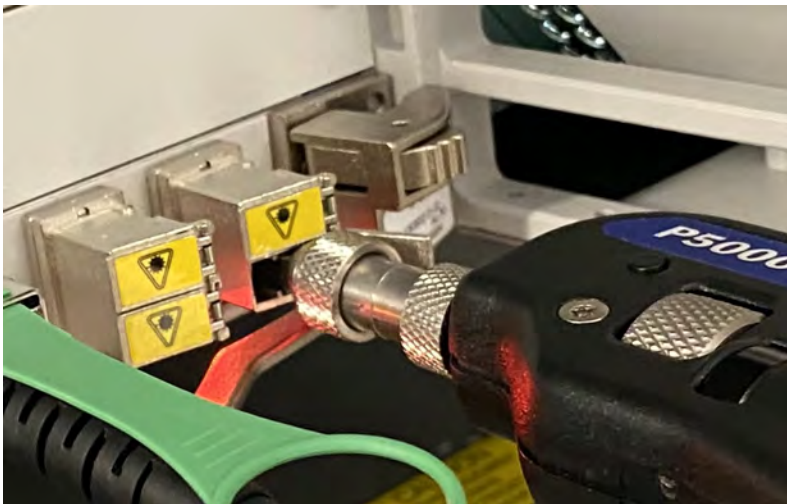
1. Move the fiber from the local mx960 router to the correct Adva network port and clean the fiber port. One could think that fiber ports with nice metallic flaps could all be clean from the factory. Most were but some looked like this.

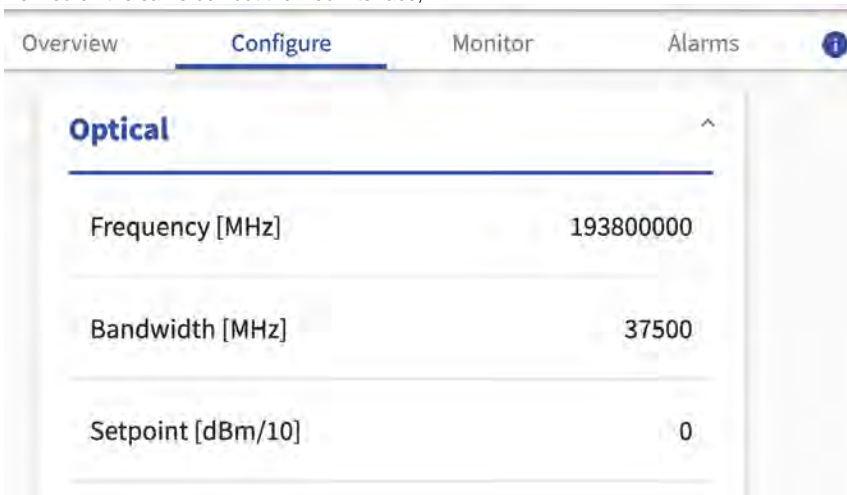
Defined on the same box but the web interface, MHz:

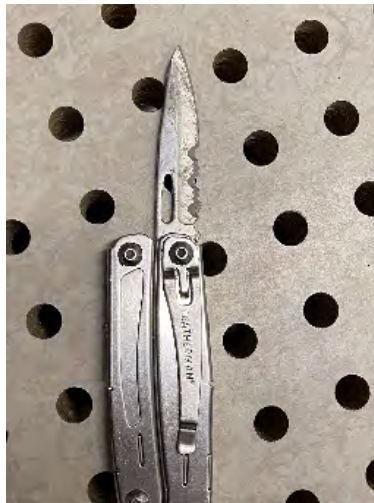
Turned out that the fiberpatch LC connector had a plastic burr from the manufacturing process that prevented the LC connector to be seated correctly in the CFP2 plug and the airgap created the extra attenuation.

solved with a leatherman

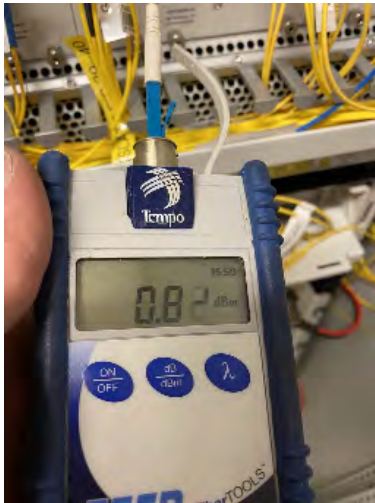
with proper levels as

result

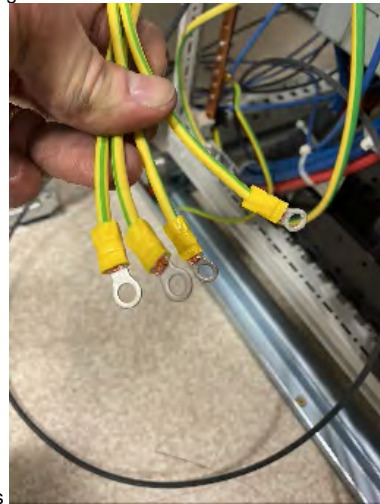
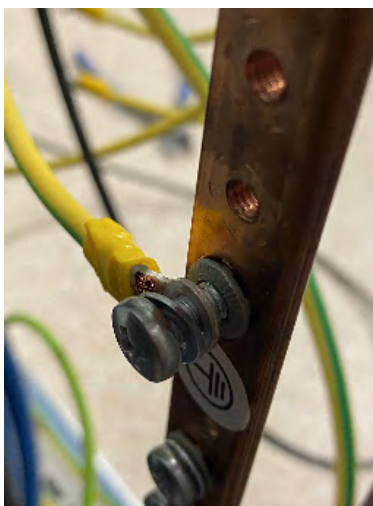
and crimped with shoes

and then placed between the tag washer and the normal washer

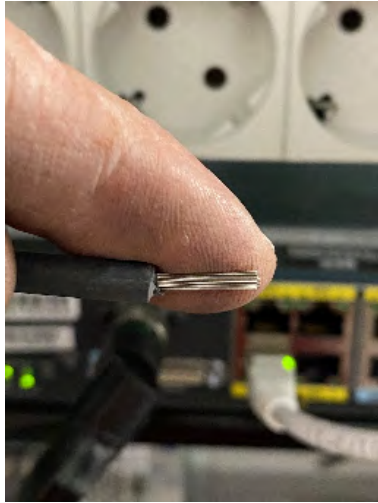
The blue and black cable from the ADVA DCI box are dual insulated cables as required by local installation laws. It means that the insulation is rather thick and that the end protection sleeves that we use on the cable will not fit over the isolation. To fix that you have to cut the insulation twice.

First the correct length of the bare wire

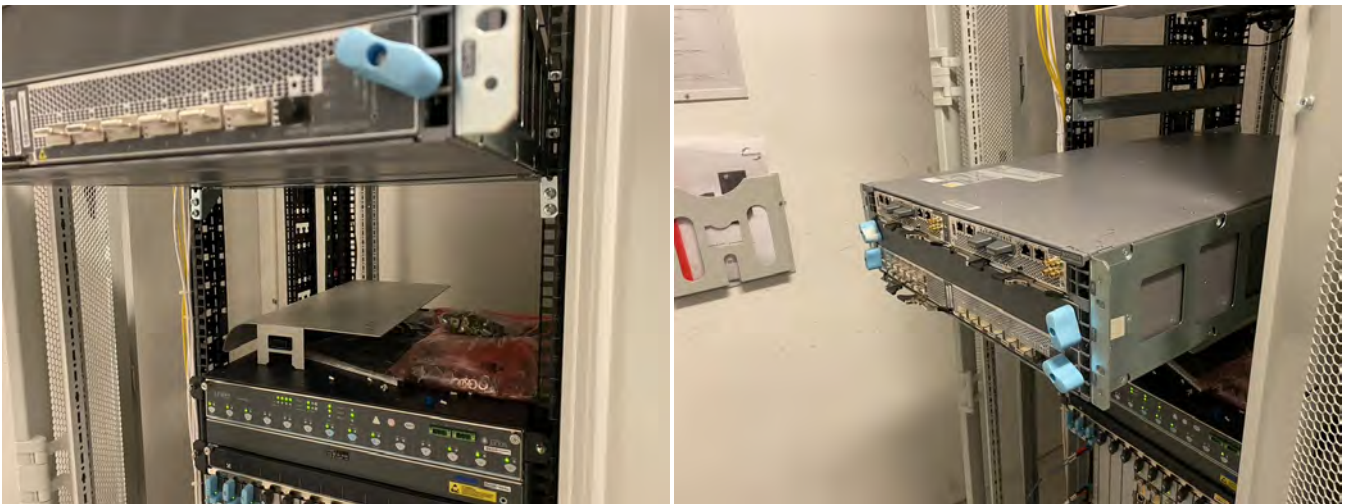
To get the router into the rack I mounted a small shelf to let the router rest on until it get screwed in.

The MX10003 has six DC PEMs, you can run it in two but it will complain and give you a chassis alarm error.

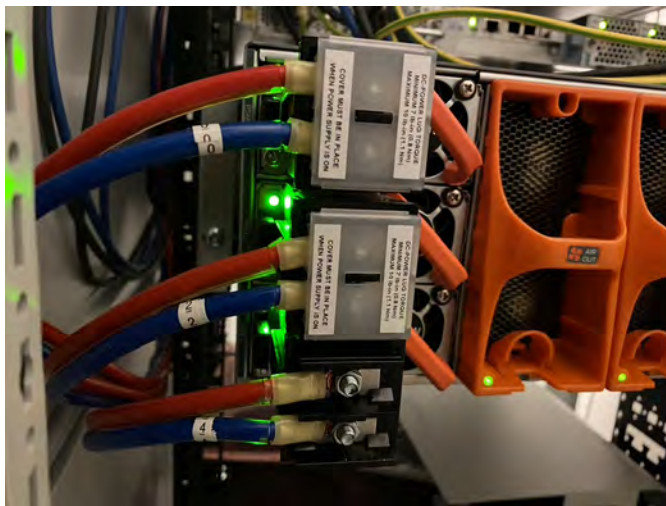
PEM 0, 2 and 4 on the left side

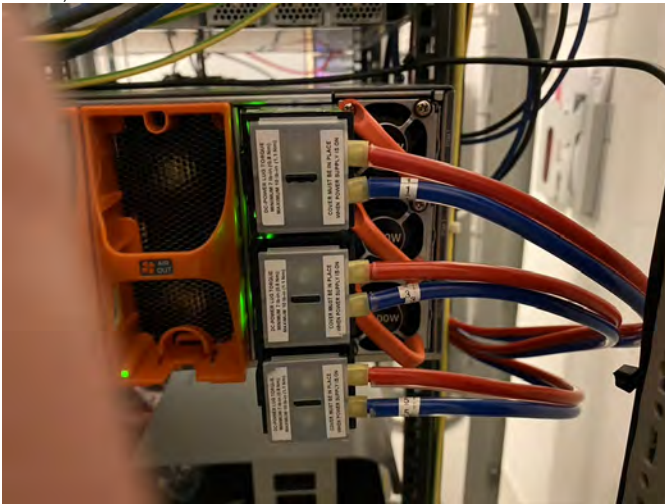
and PEM 1, 3 and 5 on the right

Here we use the same colors as the site feeds, Red + (positive) Blue - (negative)

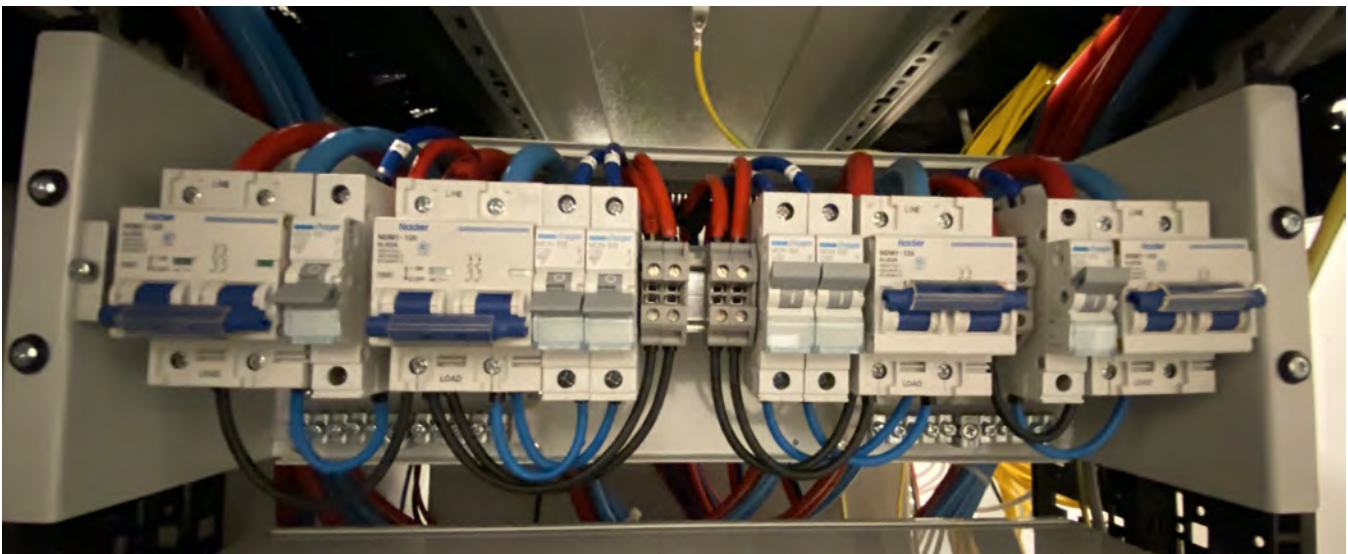
To have the both routers running at the same time the B-feed is disconnected from the PDU for the MX960 and the MX10003 are connected instead.

The feed to the PDU is 2 x 63A A-feed and 2 x 63A B-feed. The MX10003 accepts 3 x 32A A-feed and 3 x 32A B-feed. Additional breakers were installed into the PDU to divide one 63A feed to two 32A feeds and the other 63A feed to a 32A breaker so the 6mm² cables to the router can't be overloaded.

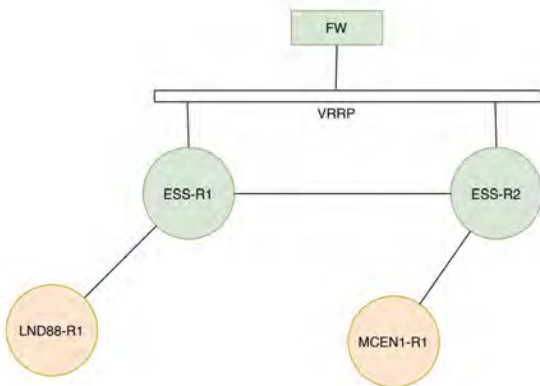
ESS has two MX80 and each router has a connection to Sunet, a link between the routers and an interface towards ESS internal network. On the link to their internal network are they running VRRP. eBGP runs between ESS and Sunet and iBGP between the two routers. They also has a bunch of L2VPN services.

Traffic was removed from the ess-r1 router by making ess-r2 VRRP master and taking down the eBGP session between ess-r1 and Ind88-r1..

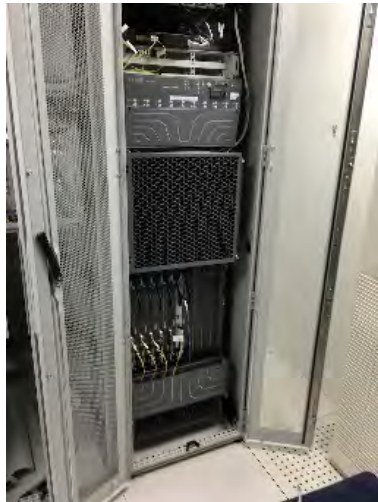
A larger site where we have three racks., 120cm deep compared to 100cm on the other core sites. The idea was that we should have the ability to place servers on four sites, Stockholm Göteborg Malmö and Luleå. So far we only have servers in Stockholm and Luleå. We also have dual AC 230V power feeds two that extra rack.

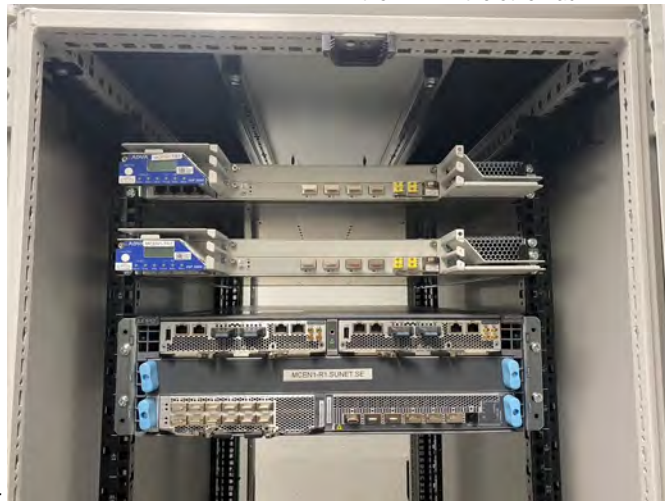
the DWDM the other rack

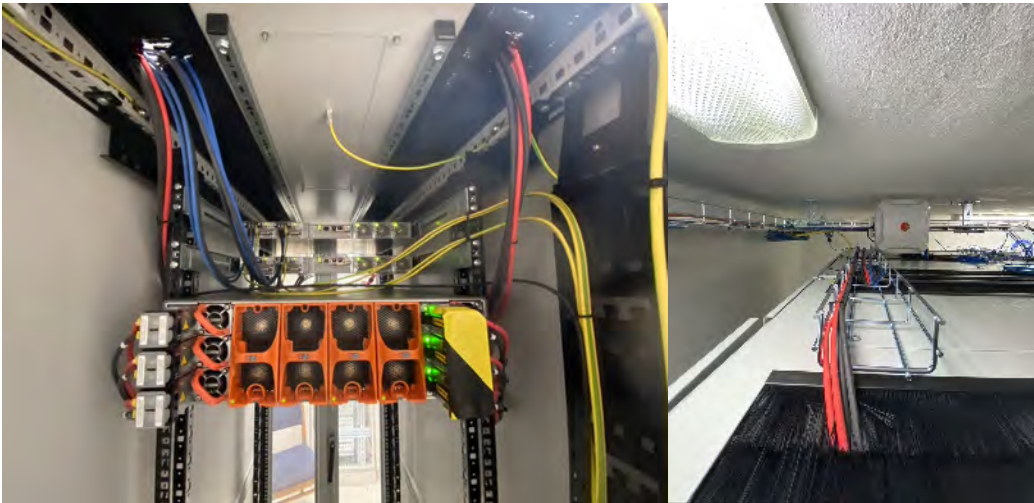
and the last rack will be used for the new gear

There are no PDU in the empty rack so the power cables had to be pulled from the MX2010 rack over the rack tops

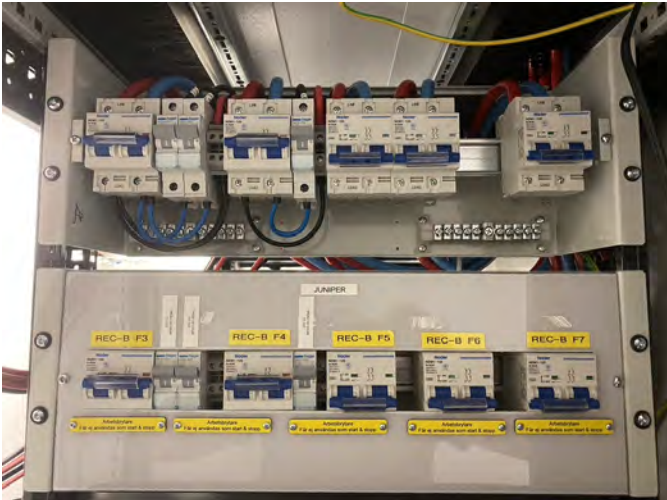
The MX2010 was connected with 5 x 63A but only 2 of the feeds were used for the new mx10003

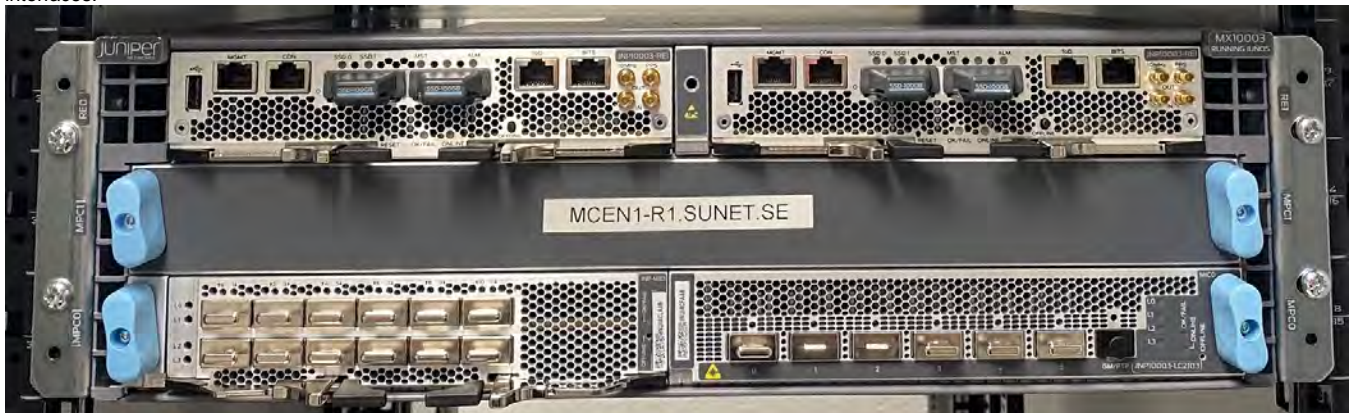
The interfaces on the MX2010 in Malmö

The MX10003 has 12 100GE interfaces and 6 40GE interfaces on one linecard. If you are using all 6 40GE interfaces you can only use 9 of the 100GE interfaces.

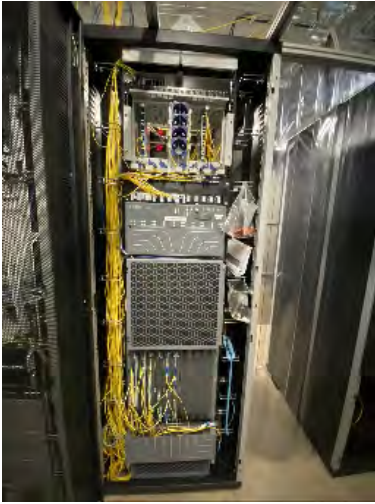
Sunet already has a DWDM nod here so the only thing to do was to install the ADVA DCI box so we can connect with 2 x 100GE to Nordunets MX2010 router

We have ordered the AOC cables from ADVA to make the last connection but in the meanwhile are we running a Juniper DWDM in the Nordunet router to the ADVA DCI in Malmö.

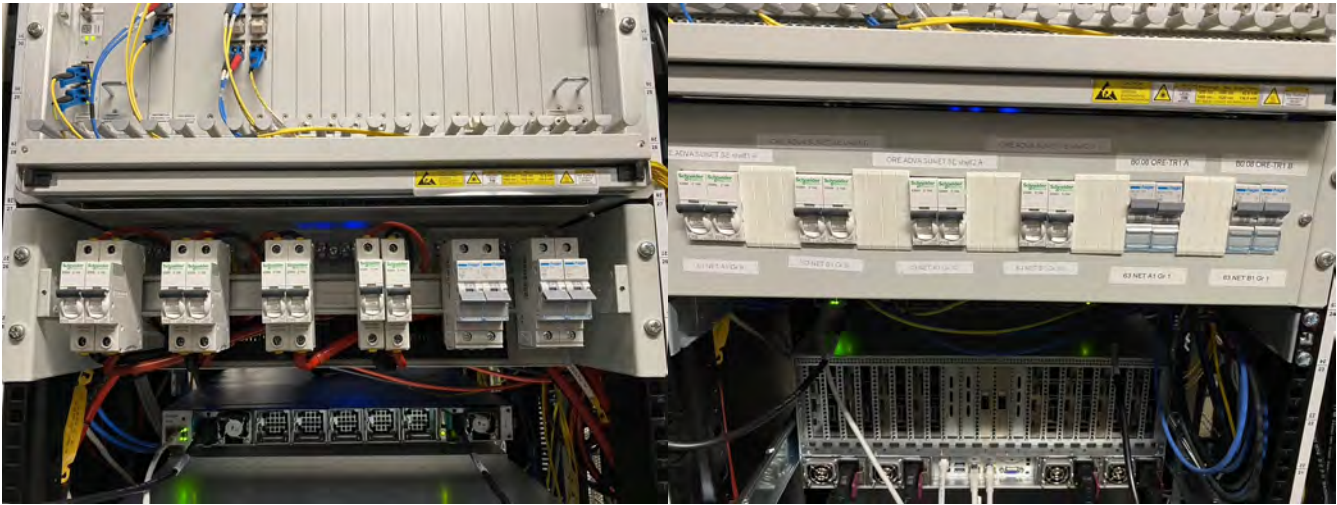
And some more power works at the back of the rack.

This PDU uses breakers on both positive and negative feed. In DK they use black and red as the colors for DC powers.

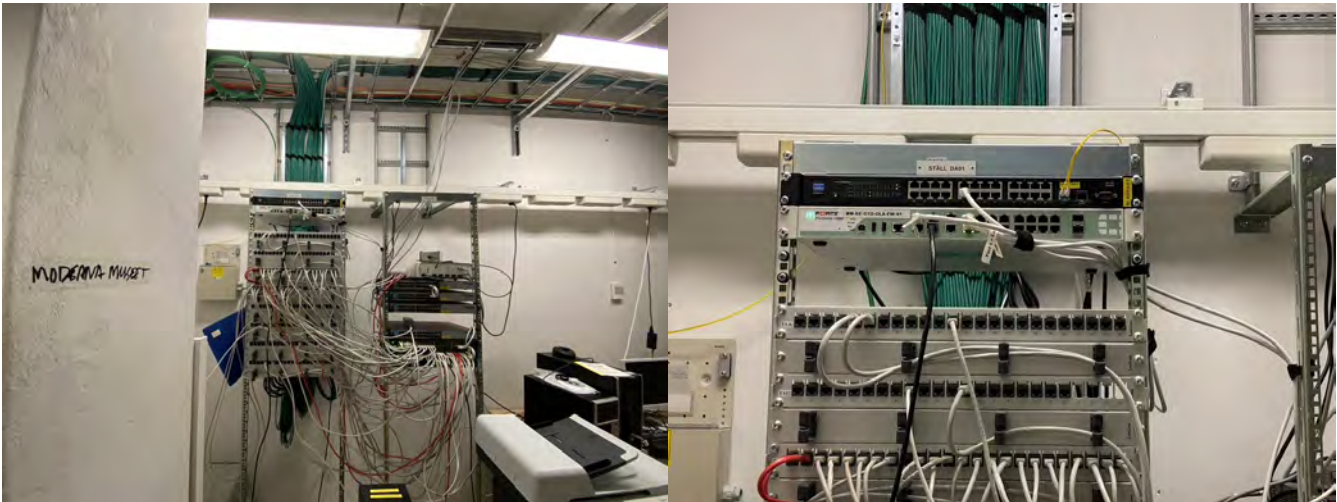
A 24 port linksys switch was used as a media converter. The fibre port flashed as one could expect. Connected my laptop to the switch and I could ping their FW but not our router.

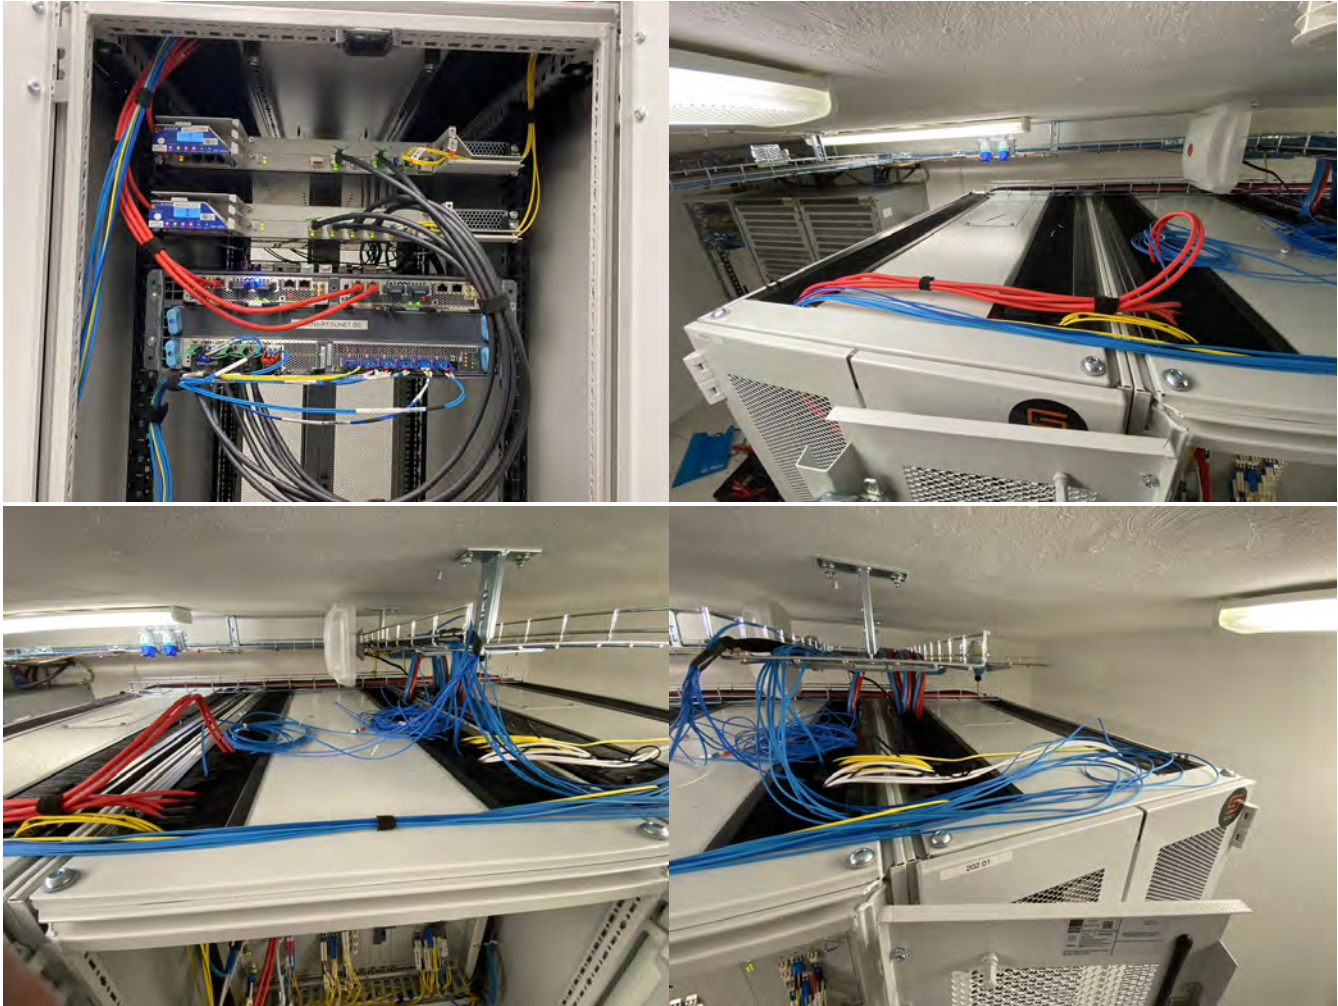
The delivery of the fibers could have been done better but, I guess it works.

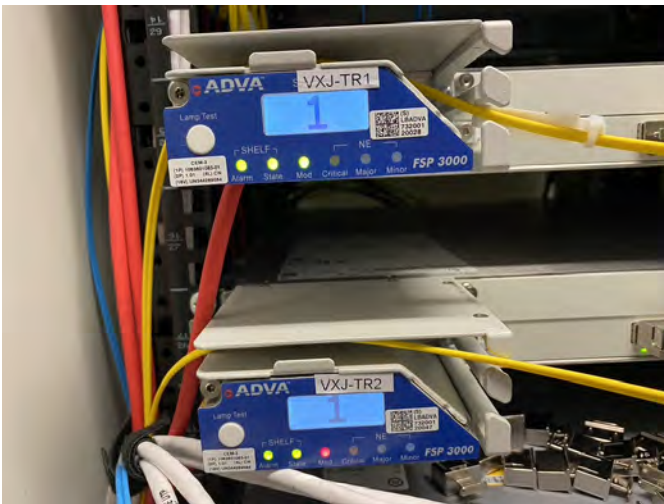
VXJ-TR2 has alarms on the frontplate but not in the admin interface, odd.

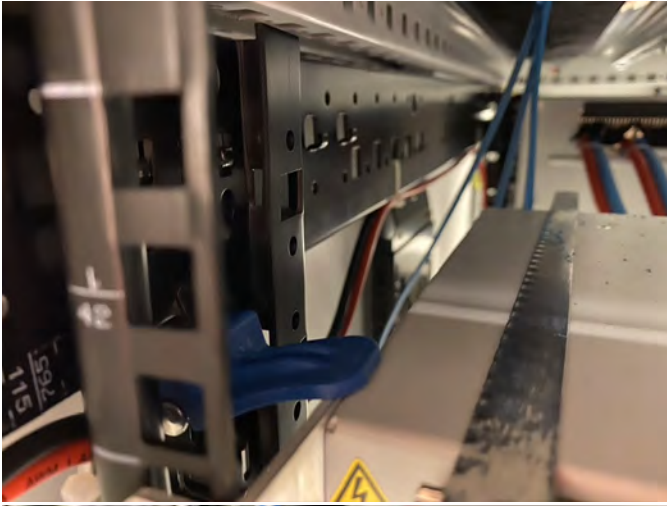
Then more work to move the rack post backwards. You need to flip those blue tabs to move the posts.

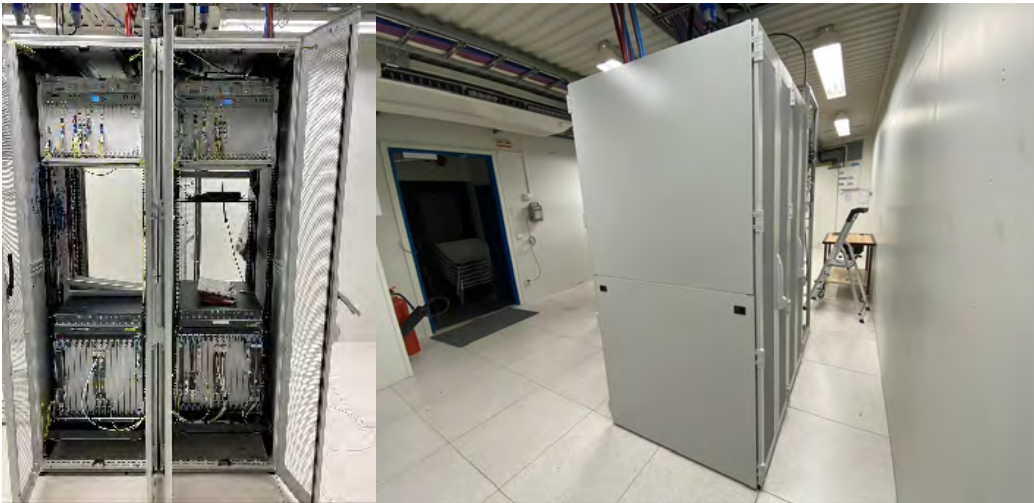
Two boxes side by side

Bos-r2 was inserted between bos-r1 and jkg-r1.
